Ercros and the Cardona Saline Valley

Terrera Nova restoration

Terrera Vella situation

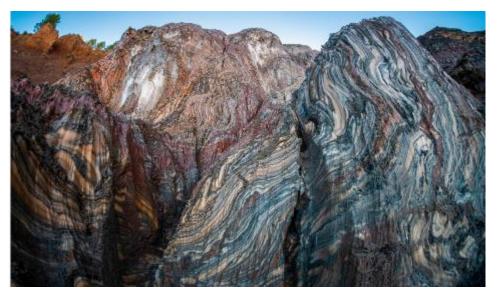
The Cardona Saline Valley is a geological formation that extends through the subsoil of the central Catalan depression. It is formed by salts precipitated during the Eocene period (37M-58M years ago) because of the evaporation of the shallow sea, which at that time covered the Ebro depression, to the Bages region. Currently, the Saline Valley is included in the Plan of Areas of Natural Interest (PEIN) of Catalonia.

The composition of the Saline Valley is varied and rich in saline compounds and minerals, such as potassium chloride and sodium chloride.

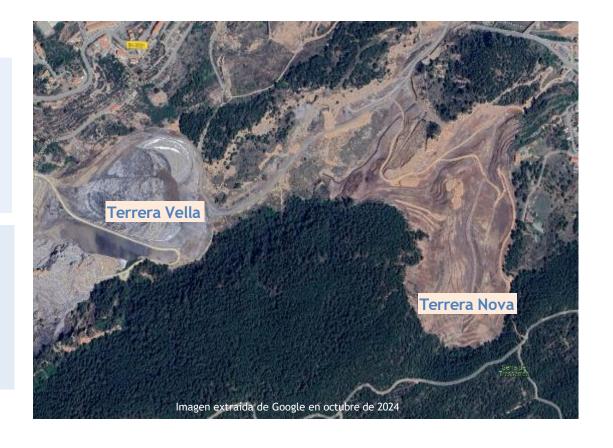
Reduction of waste landfills

Terrera Nova

- A. Image of the land before 1990, the year in which Ercros began its activity.
- B. Image in October 2024.

Terrera Vella

- A. Image of the land before 2008, the year in which Ercros began its activity.
- B. Image in October 2024.

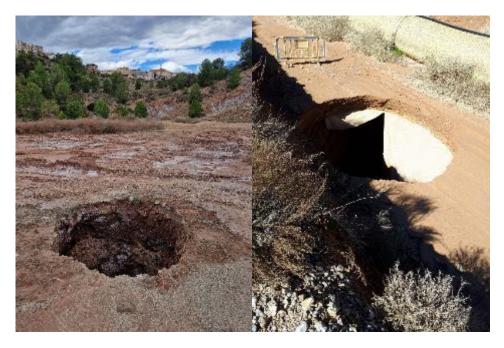
What are sinkholes?

Sinkholes are the cavities that form when rainwater and underground currents seep into the interior of a mountain of salt and dissolve the salt. The cavities thus formed within the mountain are transformed into large holes in the surface when the ground gives way.

Image taken from the publication La Vall Salina de Cardona.

Ercros has taken advantage of the mud from the purification of the salt from the mine waste landfills to fill the sinkholes of the Saline Valley in order to prevent land subsidence.

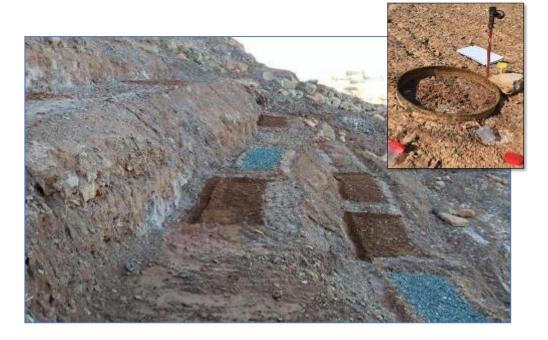
Previous test

Before starting the restoration project, Ercros has carried out tests to evaluate the water dynamics and the presence of salts in the soil.

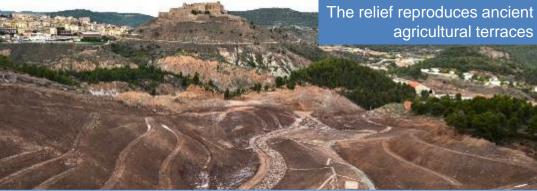
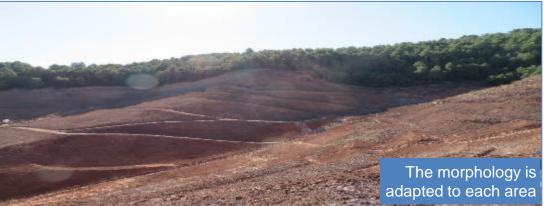
The relief has taken the original shape

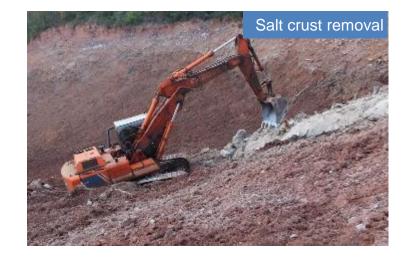
Salt is removed from the soil

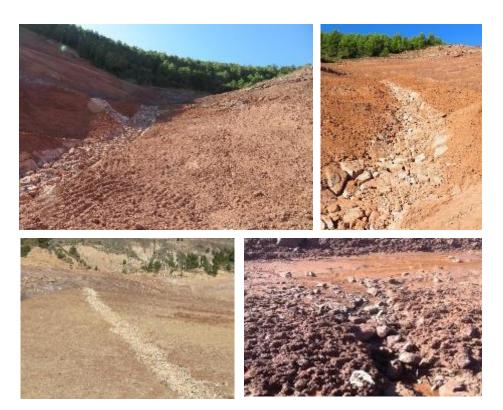
...and drainage prevents environment salinization

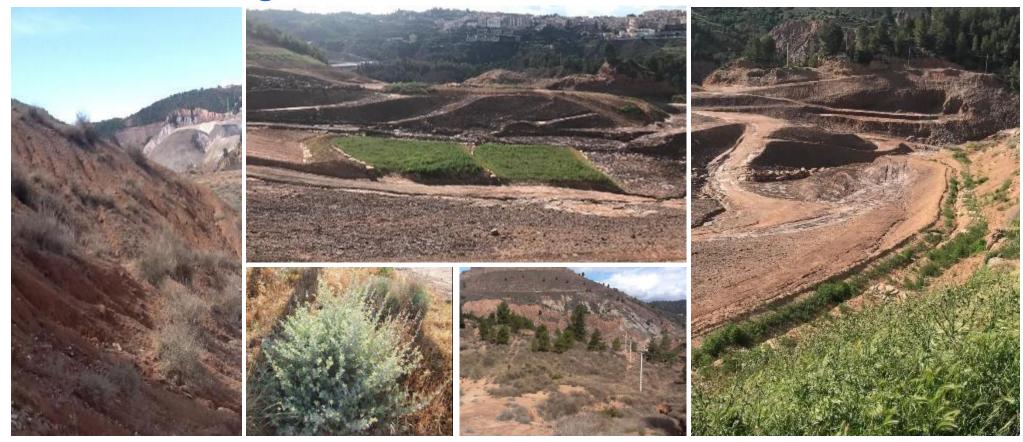
The first green shoots are here!

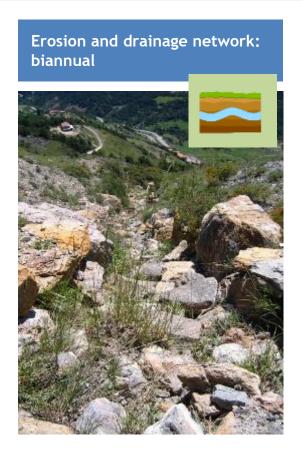
Periodic control of the actions
